# Manhole Inspection Summary

Manhole # S35G\_\_068MH

Insp Date: **11/18/08 10:11 AM**

**Location** Address: **231 e baltimore st**

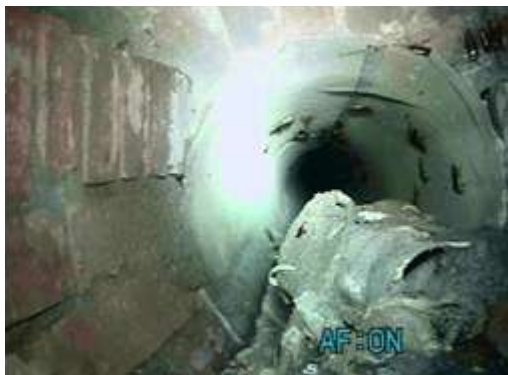
Defect 4

Channel Exposure: **Fully Open** Junc Dist: **0** nearest .5 ft. Azimuth: **0**

channel debris

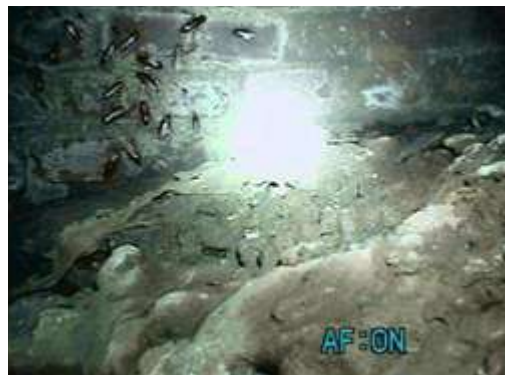
Defect 3

Condition: ☐ Sound ☐ Cracked ☐ Root Intrusion ☐ Deteriorated ☐ Leaks ☒ **Debris**

bench debris

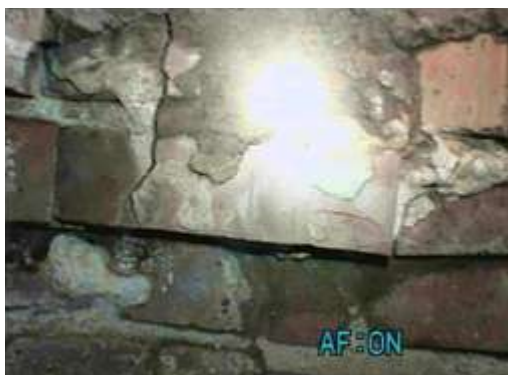
Defect 2

**Chimney / Frame Adjustment** ☒ Exists Material: **Brick and Concrete** ☐ Parged Height: **6** (in.)

Condition: ☐ Sound ☒ **Cracked** ☐ Root Intrusion ☒ **Loose Brick** ☒ **Deteriorated**

Infiltration: ☐ None ☒ **Joint** ☐ Cracks ☐ Mortar ☐ Roots ☐ Wall

Cracks, Loose Bricks and Deterioration in Chimney, Infiltration

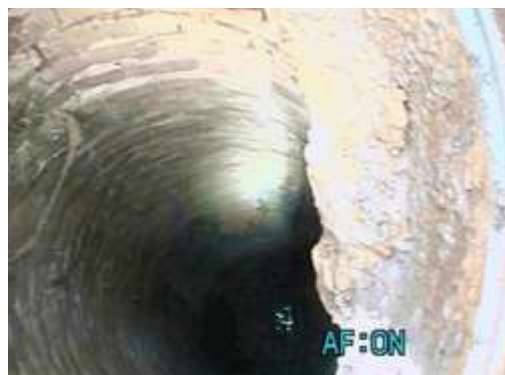
### Defect 1

**Frame** Offset: **3** (in.) Condition: ☐ Sound ☐ Cracked ☒ **Leaks**

frame offset, frame infiltration (mud deposits)

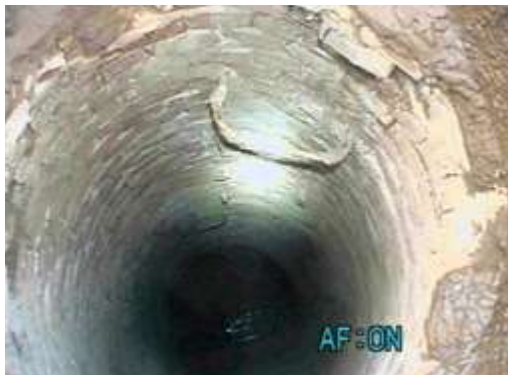
**Steps** Count: **13** Missing: **8** ☒ **Corroded**

missing steps
